NEV-CAL Home Inspections

1575 Sample St.
Anytown, USA 12345

Prepared for: Neve Cali

12:48 September 30, 2016

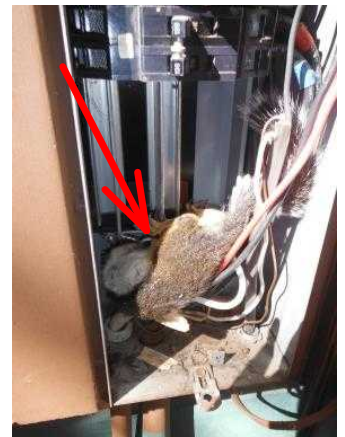
Rear of house Electric Panel

11. Defective Manufacturer: Sylvania **Improper openings at under side of power panel (probable pest access) - recommend proper closure and removal of dead animal.**

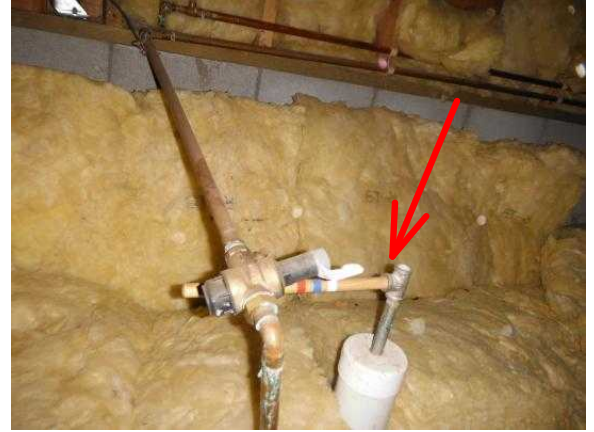
- 1. Acceptable Service Line: Unknown - assume copper
- 2. Acceptable Main Water Shutoff: Crawl space Consult seller on house winterizing procedures.

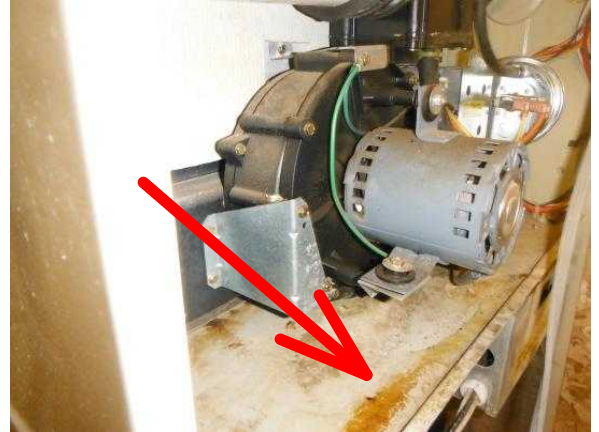
Attic Heating System

1. Defective Heating System Operation: Functional at time of inspection **Evidence of active condensate leaking inside furnace - recommend repair.**

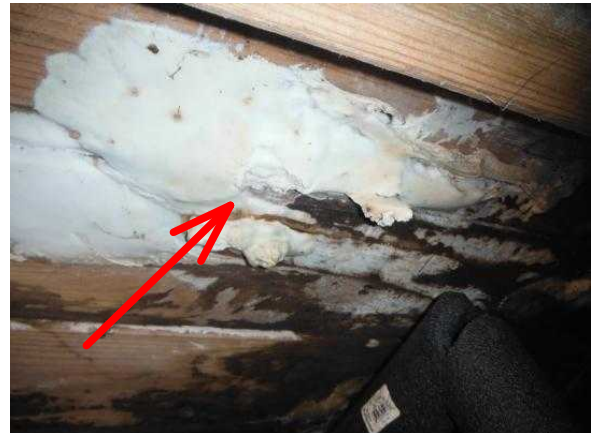
Bedroom closet Crawl Space

1. Method of Inspection: In the crawl space
2. Defective Unable to Inspect: 10% Excessive moisture and probable organic growth noted on the crawl space ceiling - consult pest report for further evaluation.

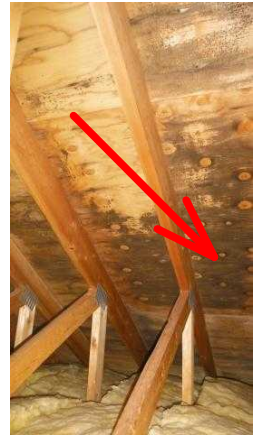
Hallway Attic

1. Method of Inspection: In the attic
2. Acceptable Unable to Inspect: 10%
3. Acceptable Roof Framing: Wood truss
4. Defective Sheathing: Plywood **Moisture staining with probable organic growth noted on north side of attic sheathing - consult pest report for further evaluation.**

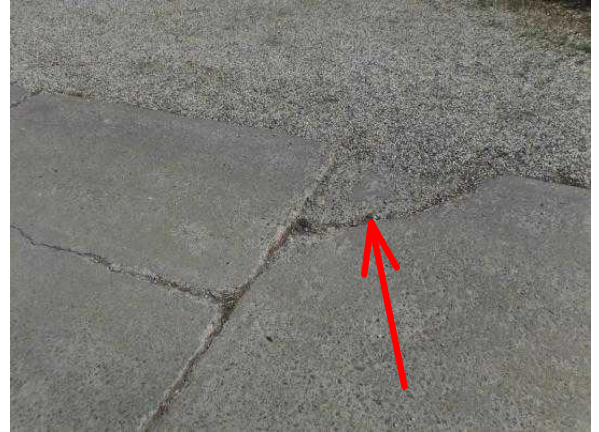
Driveway: Concrete Concrete driveway is pitted and cracked - future replacement may be necessary.

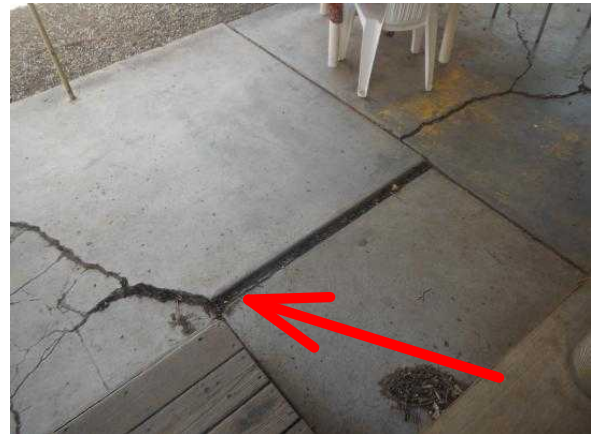
Patio: Concrete The patio slab is damaged with displacement - recommend correction.

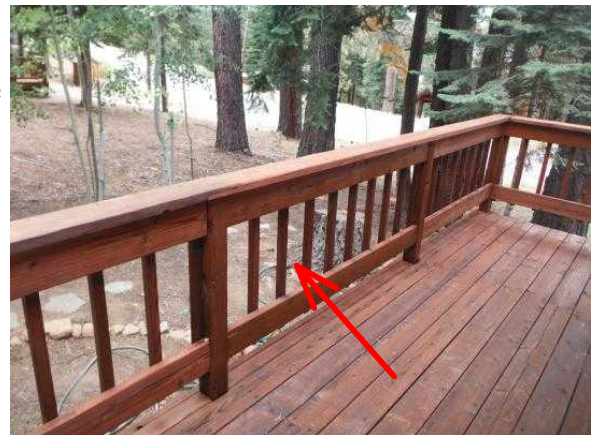
Deck: Wood Deck railing picket spacing wider than present 4" maximum spacing - recommend upgrade for safety.

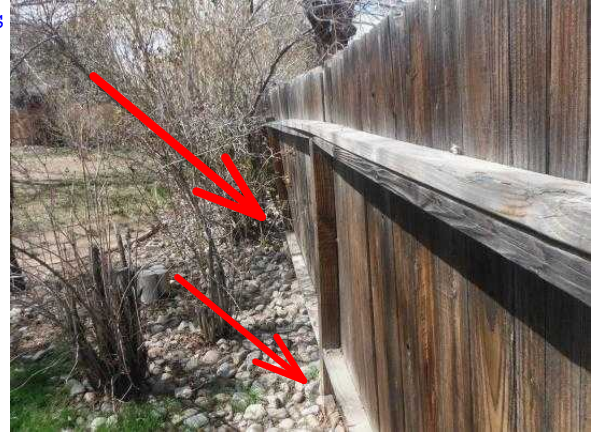
11. Marginal Fences: Wood & chain link Fence posts are deteriorating at base at 6 locations - recommend correction.

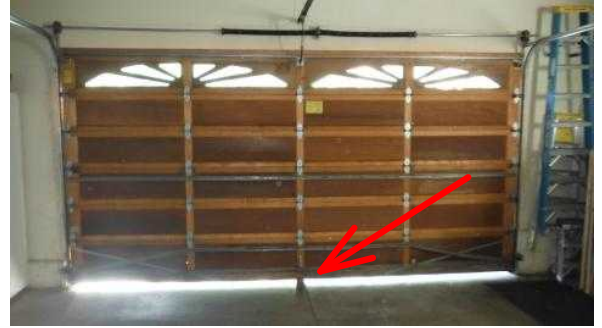
Attached Garage

1. Type of Structure: Wood structure Car Spaces: Two car
2. Acceptable Garage Doors: Insulated metal with windows
3. Acceptable Door Operation: Mechanized
4. Defective Door Opener: Lift Master 1) Motion sensor operation operated properly - notation only.
2) Down pressure reversing operation did not operate at time of inspection (red arrow) - adjustment/repair needed.

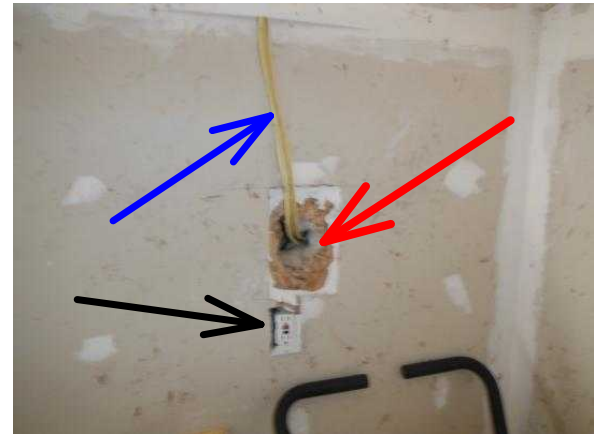
5. Defective Service Doors: Solid core Garage service door did not fully self-close & latch - adjustment/repair needed.
6. Acceptable Ceiling: Fire-taped drywall
7. Defective Walls: Fire-taped drywall Drywall damage noted in the garage fire wall (red arrow) - recommend correction for safety.

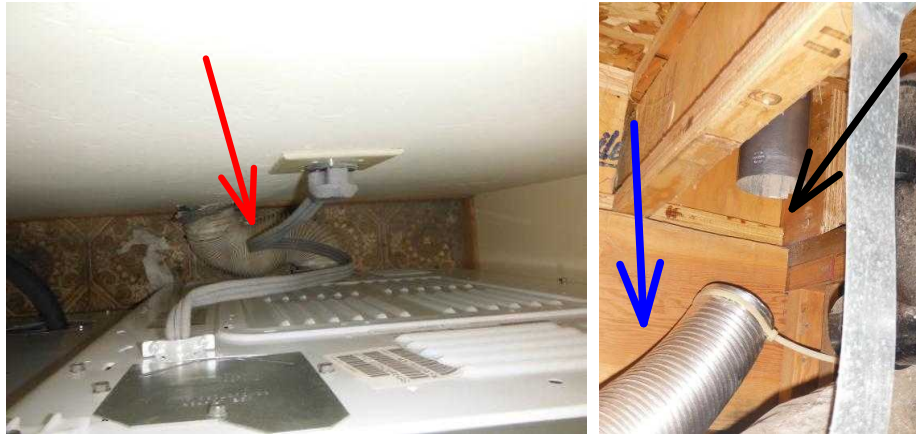
| 10. Defective | Dryer Vent: Vented to exterior 1) Plastic dryer vent connection considered to be hazardous (potential to burn - red arrow) - recommend replacement with compliant dryer vent connector. 2) Metal flex dryer vent used in crawl space to vent dryer to exterior (blue arrow) - recommend replacing with metal smooth wall dryer vent line for better dryer efficiency (normally required for present compliance). 3) Dryer vent line disconnected in crawlspace (black arrow) - repair needed. |

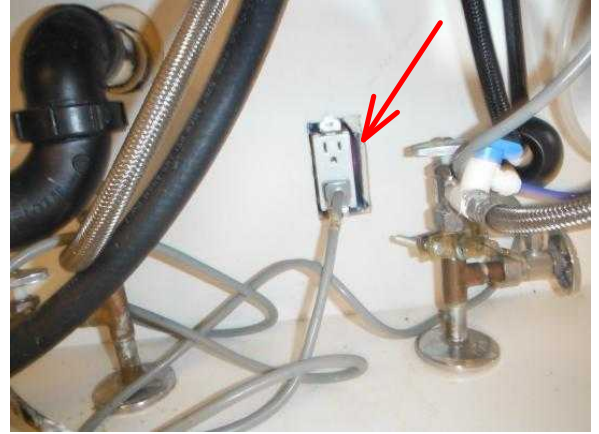
- 9. Acceptable Sink: Stainless steel - double bowl
- 10. Acceptable Plumbing/Fixtures: Single lever with ABS P-trap
- 11. Defective Electrical: 120 volt lighting & receptacles **Cover plate missing under kitchen sink (cover plate required for safety) - recommend correction for safety.**

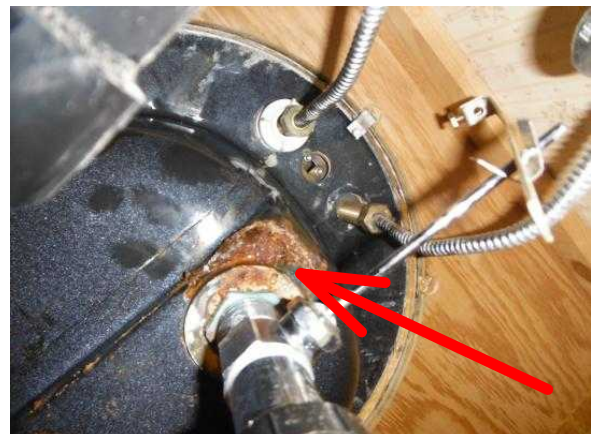
- Hall bath - main floor Bathroom
- 1. Acceptable Ceiling: Painted drywall
 - 2. Acceptable Walls: Painted drywall
 - 3. Acceptable Floor: Tile
 - 4. Acceptable Doors: Hollow core (wood)
 - 5. Acceptable Windows: Vinyl slider.
 - 6. Acceptable Electrical: 120 volt lighting & receptacles
 - 7. Acceptable Counter/Cabinet: Cultured marble top with wood cabinet
 - 8. Defective Sink/Basin: Single bowl **Bottom of sink is rusting - recommend replacement.**

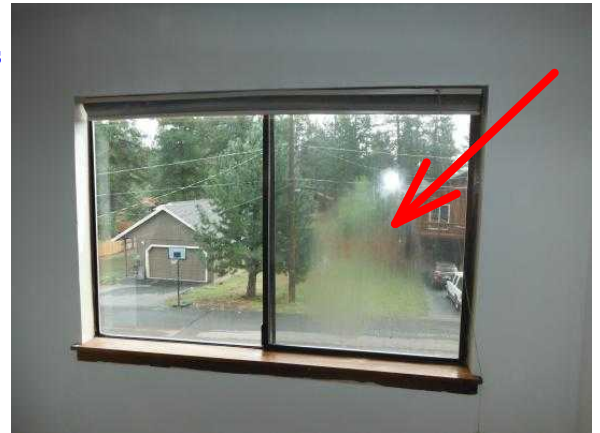
1. Acceptable Closet: Single small
2. Acceptable Ceiling: Wood
3. Acceptable Walls: Painted drywall
4. Acceptable Floor: Laminated "Pergo" type flooring
5. Acceptable Doors: Hollow core (panel)
6. Acceptable Windows: Metal slider. Window has fogging between the layers of glass - one pane.

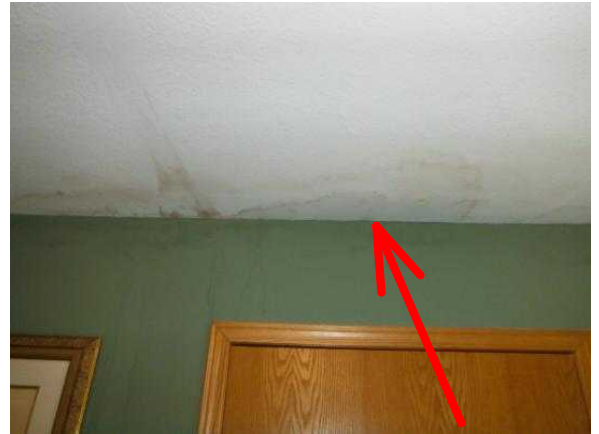
Ceiling: Painted drywall **Active moisture staining noted on ceiling in living room (moisture noted at time of inspection) - consult qualified contractor for further evaluation and repair estimate.**

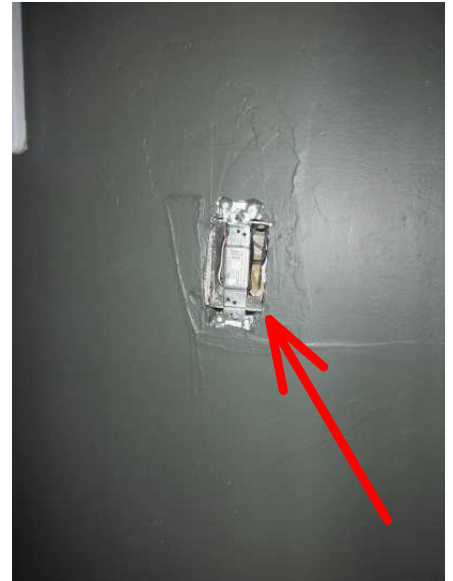
Electrical: 120 volt lighting **Cover plate missing at light switch - cover plate required for safety.**

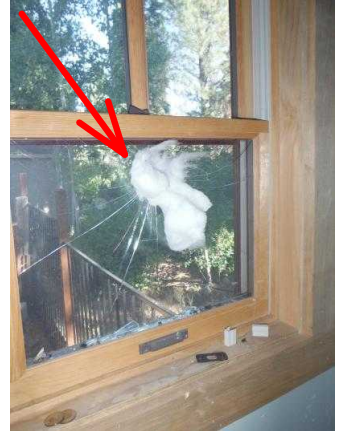
| 6. Defective | Windows: Wood double hung. Window is broken - contact glass company for repair estimate. |

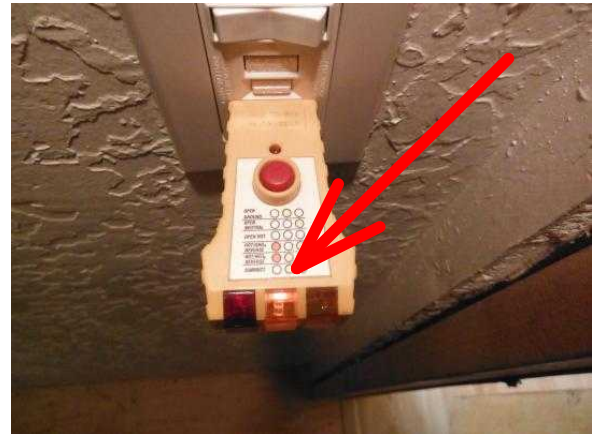
| 7. Defective | Electrical: 120 volt outlets plus switch controlled receptacle for lighting Open or missing ground at west side wall receptacle - recommend correction for safety. |

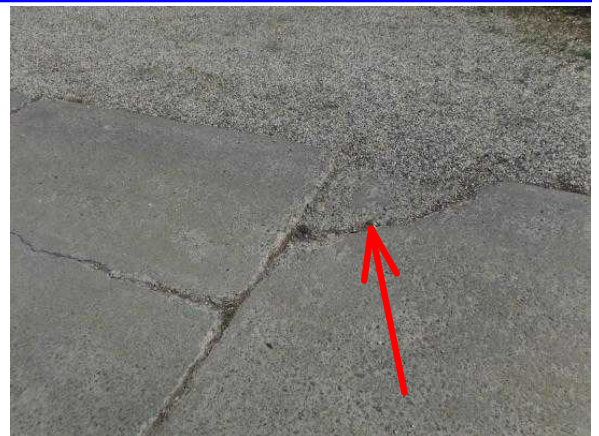
5. Driveway: Concrete Concrete driveway is pitted and cracked - future replacement may be necessary.

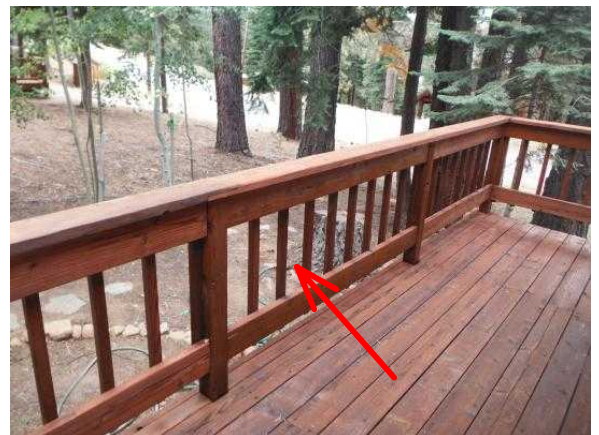
6. Deck: Wood Deck railing picket spacing wider than present 4" maximum spacing - recommend upgrade for safety.

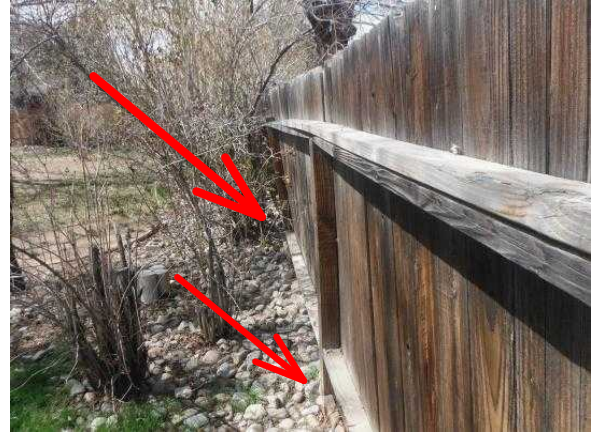
7. Fences: Wood & chain link Fence posts are deteriorating at base at 6 locations - recommend correction.

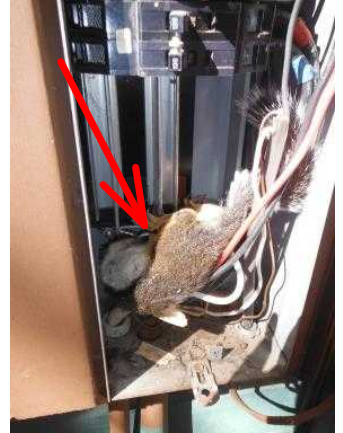
1. Ground: Driven ground rod **Ground bond for water & gas lines are missing (required for safety) - recommend correction.**
2. Rear of house Electric Panel Manufacturer: Sylvania **Improper openings at under side of power panel (probable pest access) - recommend proper closure and removal of dead animal.**

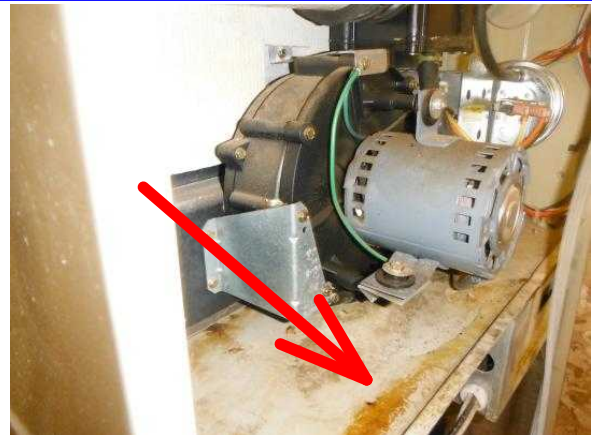
3. Attic Heating System Heating System Operation: Functional at time of inspection **Evidence of active condensate leaking inside furnace - recommend repair.**

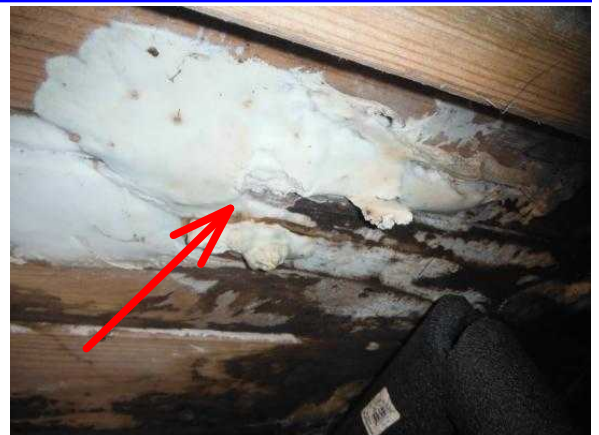
4. Bedroom closet Crawl Space Unable to Inspect: 10% **Excessive moisture and probable organic growth noted on the crawl space ceiling - consult pest report for further evaluation.**

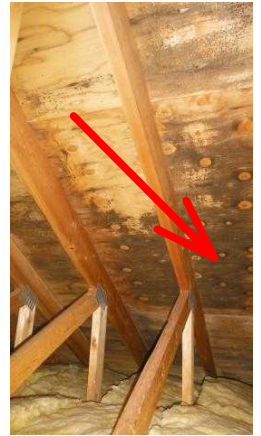
7. Hallway Attic Sheathing: Plywood Moisture staining with probable organic growth noted on north side of attic sheathing - consult pest report for further evaluation.

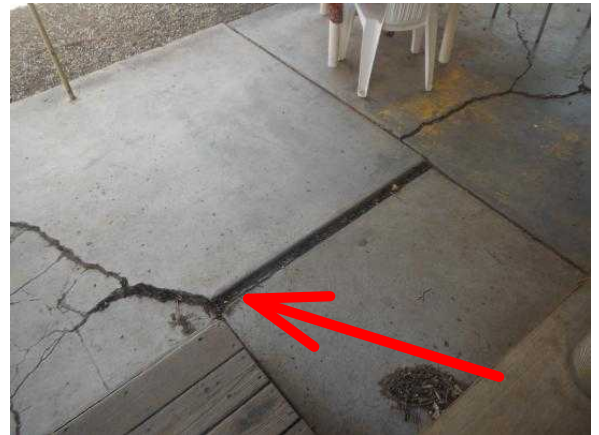
8. Patio: Concrete The patio slab is damaged with displacement - recommend correction.

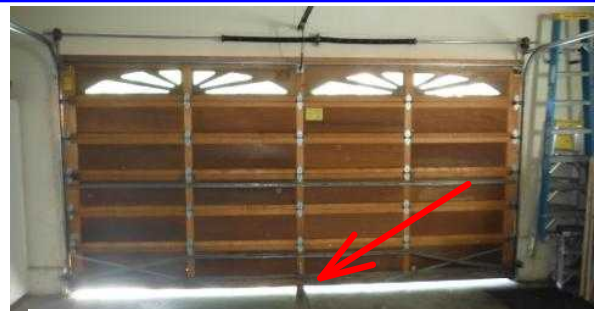
10. Attached Garage Door Opener: Lift Master 1) Motion sensor operation operated properly - notation only.
2) Down pressure reversing operation did not operate at time of inspection (red arrow) - adjustment/repair needed.

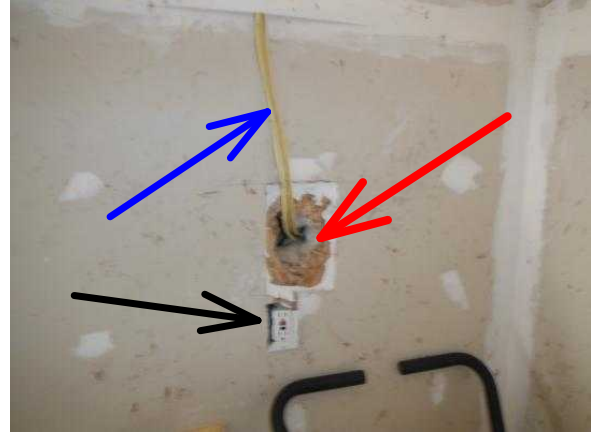
11. Attached Garage Service Doors: Solid core Garage service door did not fully self-close & latch - adjustment/repair needed.
12. Attached Garage Walls: Fire-taped drywall Drywall damage noted in the garage fire wall (red arrow) - recommend correction for safety.

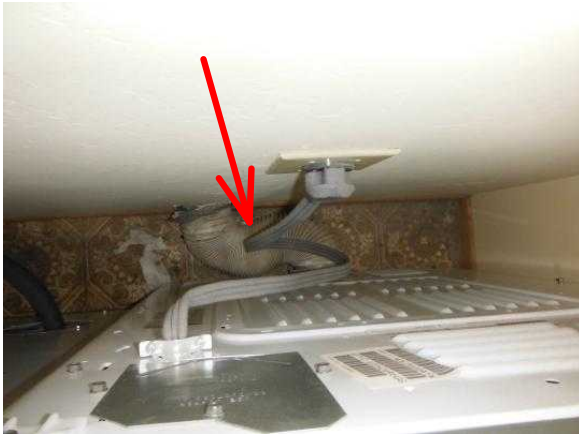
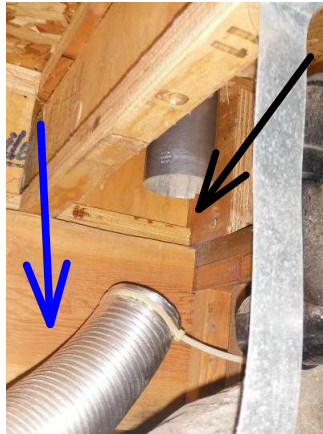
13. Main floor Laundry Room/Area Dryer Vent: Vented to exterior 1) Plastic dryer vent connection considered to be hazardous (potential to burn - red arrow) - recommend replacement with compliant dryer vent connector.
2) Metal flex dryer vent used in crawl space to vent dryer to exterior (blue arrow) - recommend replacing with metal smooth wall dryer vent line for better dryer efficiency (normally required for present compliance).
3) Dryer vent line disconnected in crawlspace (black arrow) - repair needed.

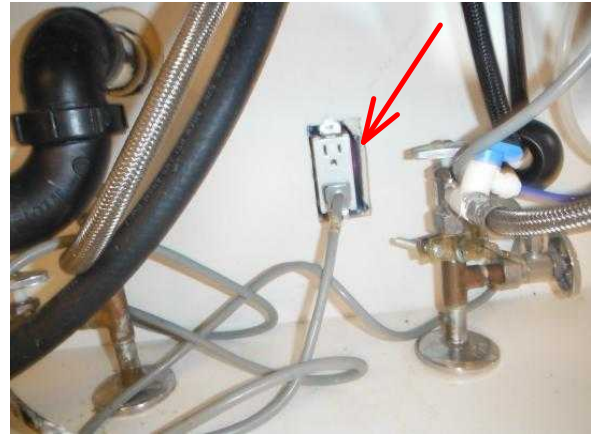
15. Main floor Kitchen Electrical: 120 volt lighting & receptacles **Cover plate missing under kitchen sink (cover plate required for safety) - recommend correction for safety.**

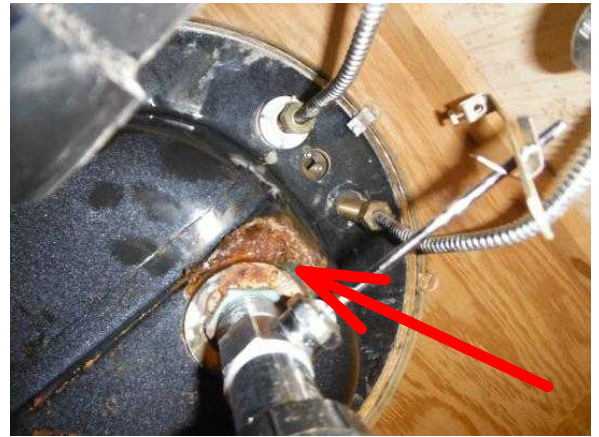
16. Hall bath - main floor Bathroom Sink/Basin: Single bowl **Bottom of sink is rusting - recommend replacement.**

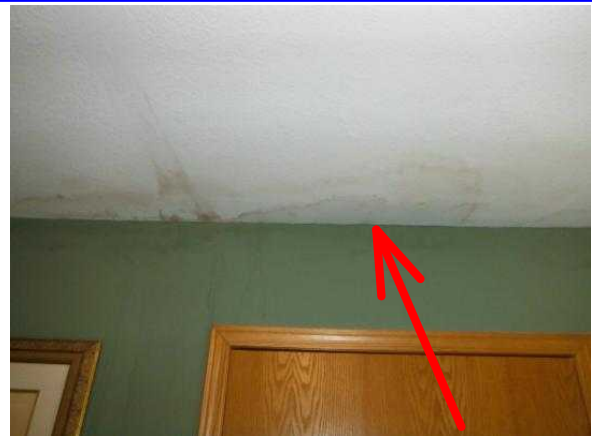
18. Hallway - main floor Living Space Ceiling: Painted drywall **Active moisture staining noted on ceiling in living room (moisture noted at time of inspection) - consult qualified contractor for further evaluation and repair estimate.**

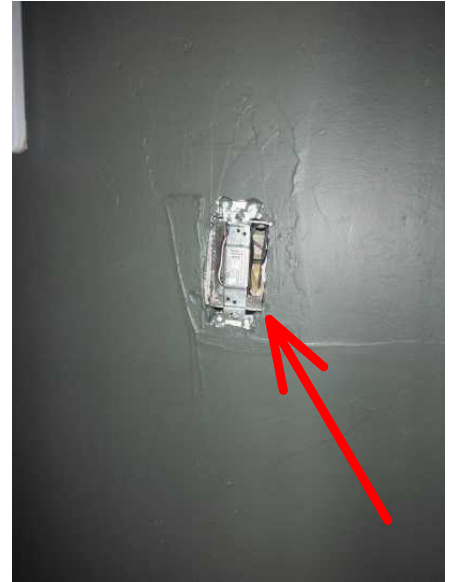
19. Hallway - main floor Living Space Electrical: 120 volt lighting **Cover plate missing at light switch - cover plate required for safety.**

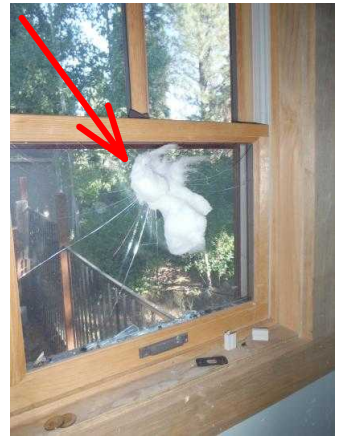
20. 1st floor - east Bedroom Windows: Wood double hung. **Window is broken - contact glass company for repair estimate.**

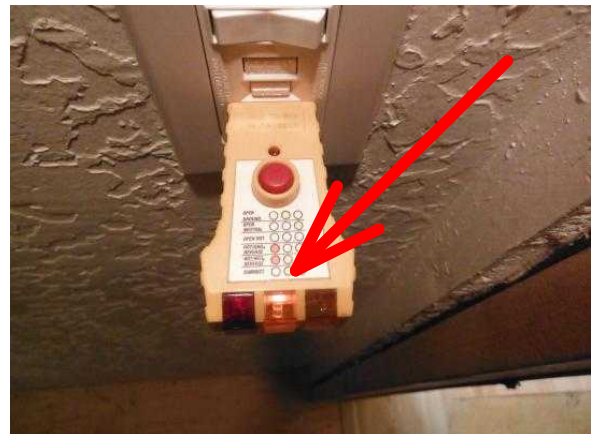
21. 1st floor - east Bedroom Electrical: 120 volt outlets plus switch controlled receptacle for lighting **Open or missing ground at west side wall receptacle - recommend correction for safety.**
